I.0 Goring Hall Conservation Area: An Overview

Goring Hall Summary of Significance

Goring Hall Conservation Area

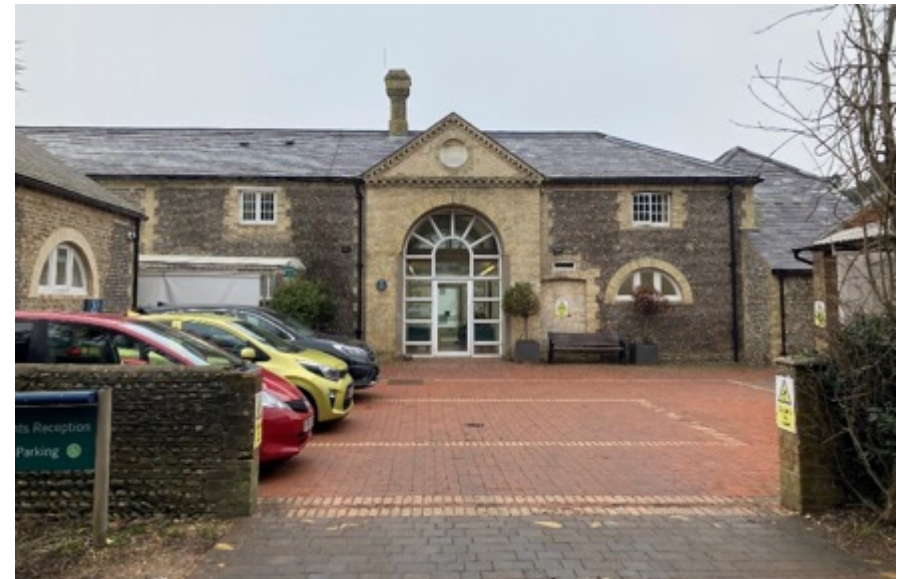
Figure 13: Former Stable building to Goring Hall (listed grade II)

- 4.13 Within the grounds of Goring Hall there are a number of outbuildings which relate to the historic running of the house. The historic stable block (listed grade II) to the north of the hall (and now attached via a modern extension) is a brick and flint building similar to the other historic structures within the grounds. These reflect the materials found within the local area. The flint walls that enclose the grounds, service areas and walled garden are all reflective of boundary treatments within the conservation area and wider locale.

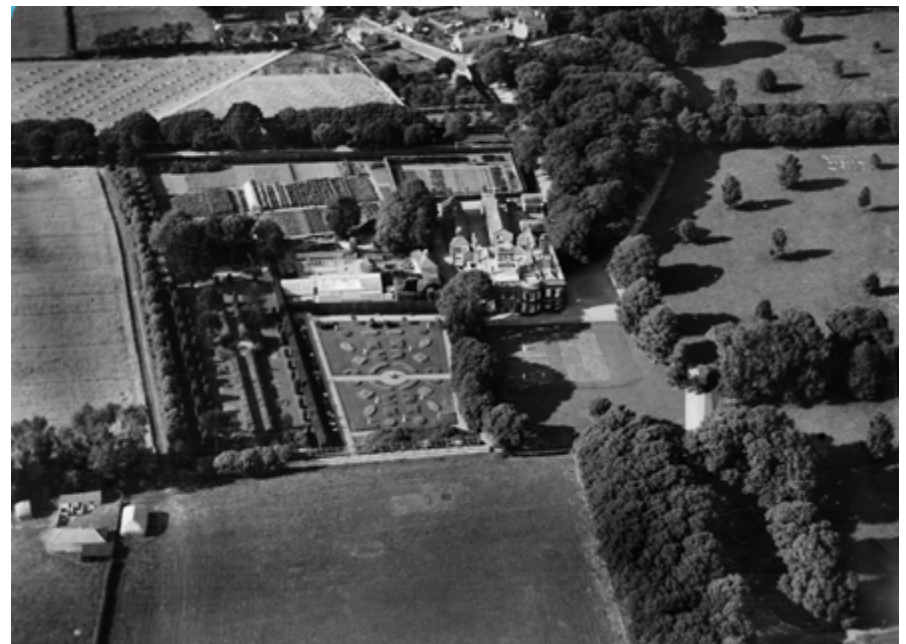
Figure 14: Goring Hall Estate, 1924; Source: Britain from Above

- 4.15 An aerial photograph of 1924 shows the grounds to Goring Hall in greater detail. The ornamental Italianate gardens appear very well maintained at this date, with glasshouses, kitchen gardens and stabling west and north of the house. A pergola runs the length of the terrace, and the lawns immediately south of the house have tennis courts installed by this date.

- 4.16 Parkland is shown to the east of the house, with the Ilex Avenue and The Plantation well established. The parkland today has been lost to 20th century housing development.

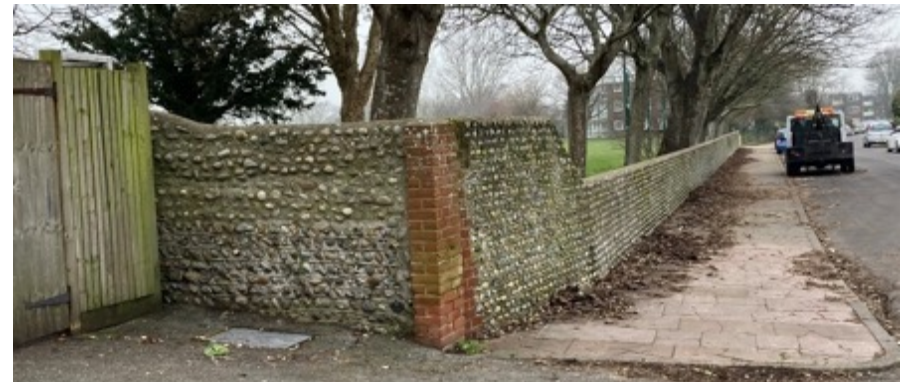
Figure 17: Flint wall to the north of The Bull's Head within the conservation area.

4.19 The Bull's Head and the flint wall to the north marks the northern extent of the conservation area. This building has entrances on Goring Street and can be accessed off Fernhurst Drive. The Bull's Head is surrounded by areas of hardstanding, in contrast to the more verdant character found elsewhere within the conservation area. To the west (rear) of the building there is a beer garden which reflects the green character of the area with mature trees and open space, but to the front of the public house the carpark provides a large area of hardstanding that detracts from its setting. A flint boundary wall runs to the north of The Bull's Head alongside the pavement of Goring Street and is another example of this type of boundary treatment that is seen throughout the local area.

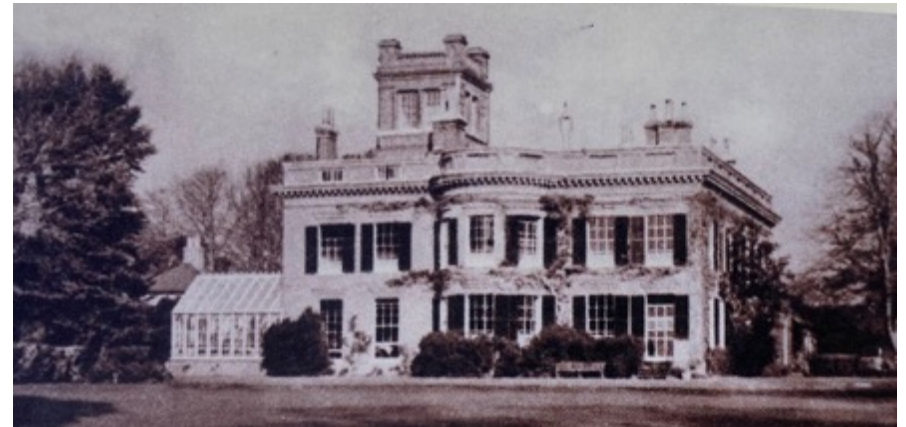
Figure 19: An early photograph of Goring Hall prior to its reconstruction in 1888

- 4.23 The conservation area is centred on Goring Hall, its historic approaches and associated buildings. Goring Hall is the principal building within the conservation area, but the historic outbuildings, North Lodge and The Bull's Head are also architecturally interesting and key historic buildings within the conservation area.
- 4.24 Goring Hall, while not readily visible from outside of its own grounds, is of considerable importance to the history of Goring and the conservation area. Dating back to 1838 the rebuilt replica house dates to 1888 and was

built in the Queen Anne style, in contrast to the more neo-classical appearance of the original building which was rendered. It has been altered and extended in the 20th century, but retains a sense of the original building. Although not the oldest building within the conservation area (The Bull's Head has 16th century elements behind an 18th century façade), it is the grandest. The building is set within substantial grounds and the remaining service buildings in flint and yellow brick also contribute to the architectural interest of the conservation area. The flint buildings in particular are characteristic of the vernacular tradition of the locale.

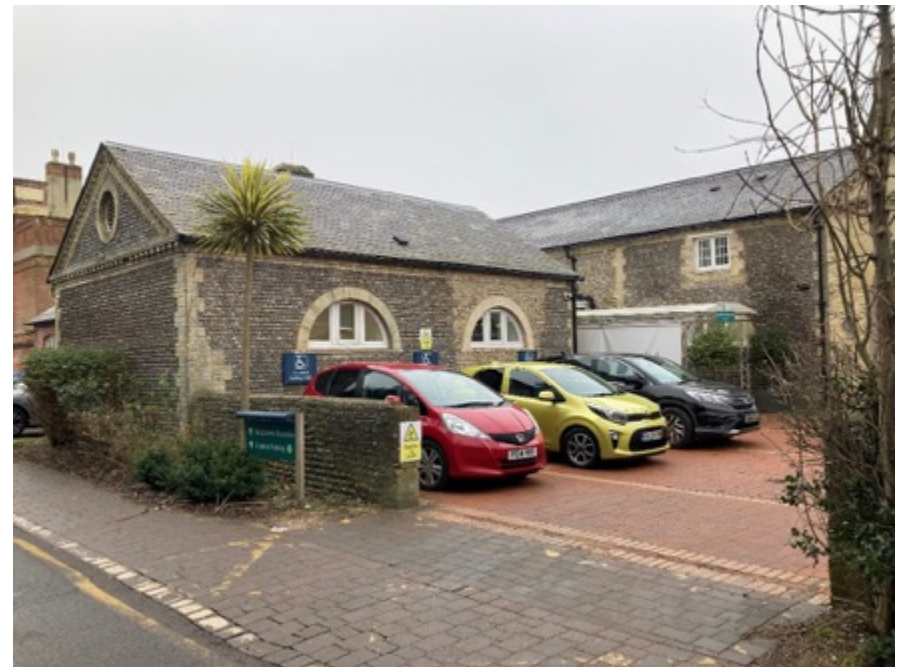
Figure 26: Examples of paving treatments in Goring Hall grounds.

- 4.33 The unifying feature of the conservation area are the extensive flint boundary walls, which surround the historic Goring Hall estate and the land to the north of The Bull's Head. The flint walls are not homogenous, but vary in terms of their height, intactness, quality and age. Some are built of coursed cobbled flints, while others are made of broken flints laid in a more random arrangement.
- 4.34 Roads and pavements throughout the conservation area are predominantly in modern tarmac or concrete paving slabs. The Ilex Avenue is a dirt track, closed to vehicles. The historic approach to the Goring Hall Estate from North Lodge is covered in gravel, disguising any earlier road treatment. Within Goring Hall grounds, the predominant road material is tarmac, but there are examples of brick and block paving within the historic service yard area.
