1.0 Goring Hall Conservation Area: An Overview

Goring Hall Summary of Significance

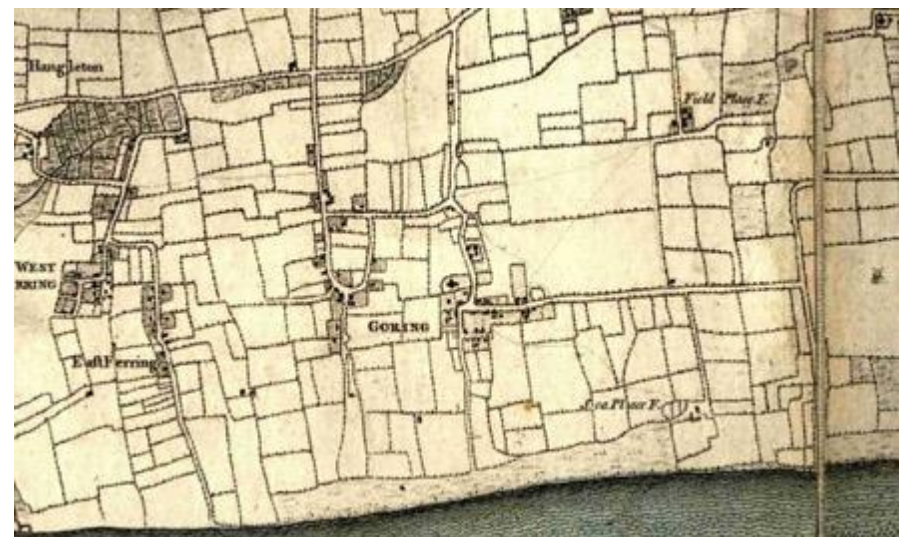
Figure 4: Yeakell and Gardner's Sussex 1778-1783, 2inch to 1 mile

- 3.18 The Yeakell and Gardner Sussex map of 1778-1783 shows the layout of Goring. The land that comprises the conservation area is largely devoid of built form which is clustered around the church and the present A259. The Bull's Head Inn, a prominent building within the conservation area is present on this map, but Goring Hall is yet to be built and its location shows some buildings and field layouts, but no main residence with the formal grounds that are seen later.

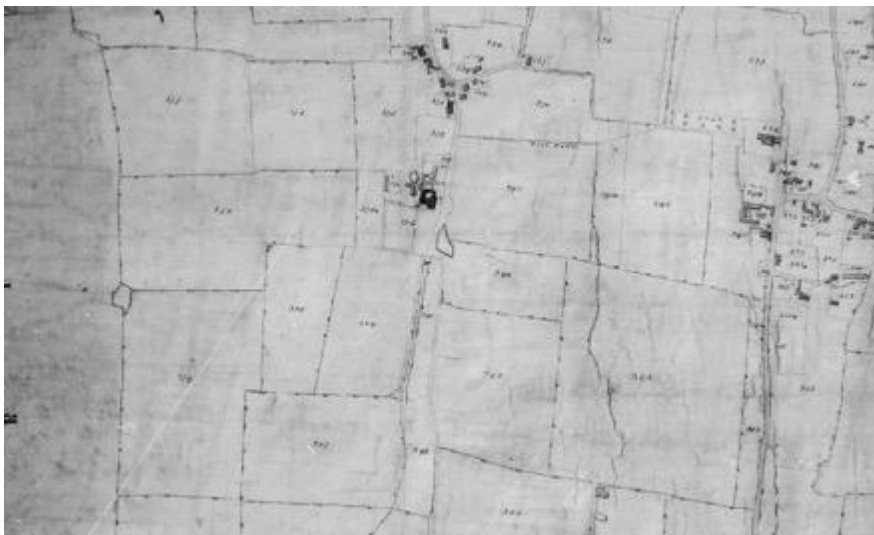
Figure 5: 1843 Tithe Map

- 3.19 The 1843 Tithe Map shows some change to the built form within the conservation area. On this map Goring Hall and its surrounding outbuildings are now present. The Ilex Avenue and plantation are not shown on this map and do not seem to have been planted yet. To the north of the hall, around the present A259 there appears to have been little change to the built form. The Bull's Head Inn is present on this map with limited other housing surrounding it.

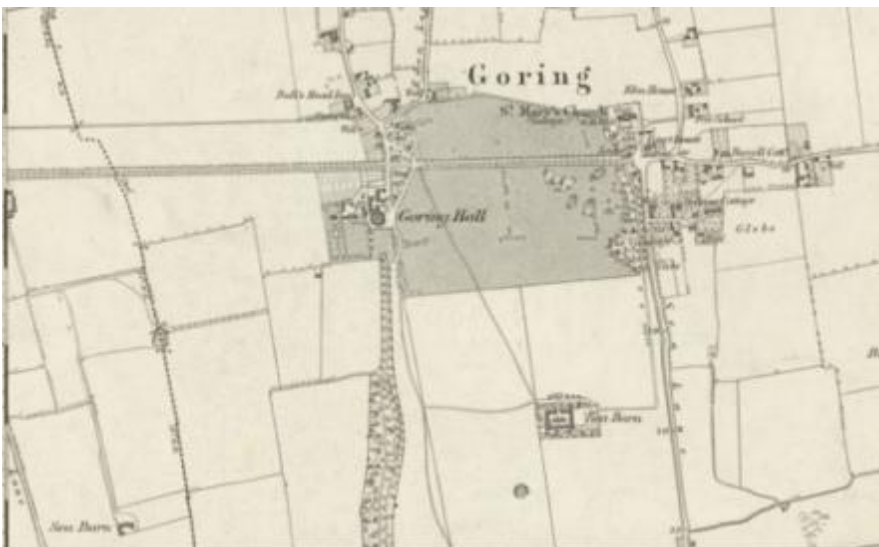
Figure 6: Sussex Sheet LXIV 1875 pub 1879

3.20 The 1875 Ordnance Survey (OS) map shows limited change to the built form within the conservation area, but the Ilex Avenue on the approach to Goring Hall and The Plantation are present on a map for the first time. This map also shows the layout of the grounds at Goring Hall with the formal grounds located to the east of the house and the parkland to the north and west.

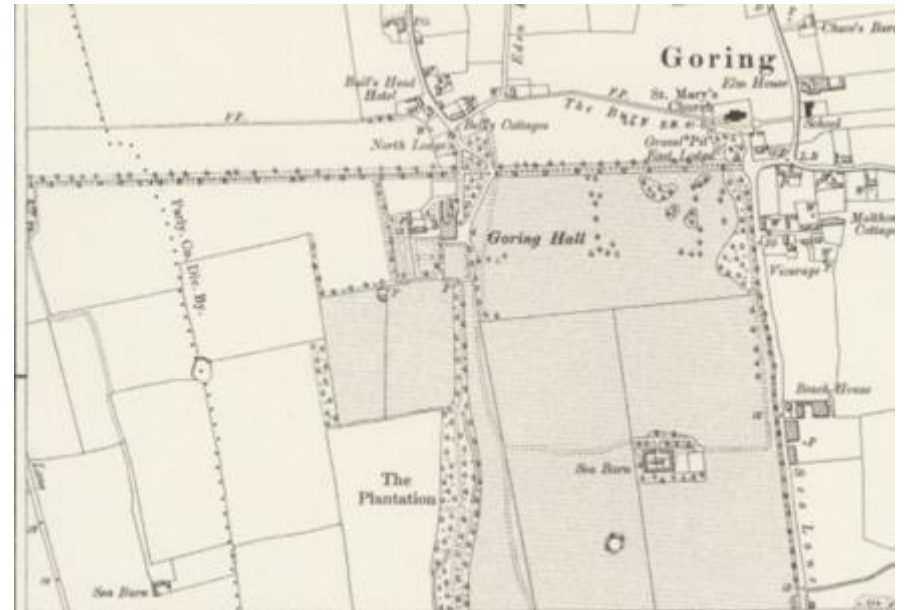
Figure 7: Sussex Sheet LXIV.SW Revised: 1896, Published: 1899

3.21 There is limited change to the built form between the 1879 and 1899 OS map. While there is some change to the footprint of Goring Hall, following the fire and rebuilding of 1888 it remains largely within the same footprint as previously.

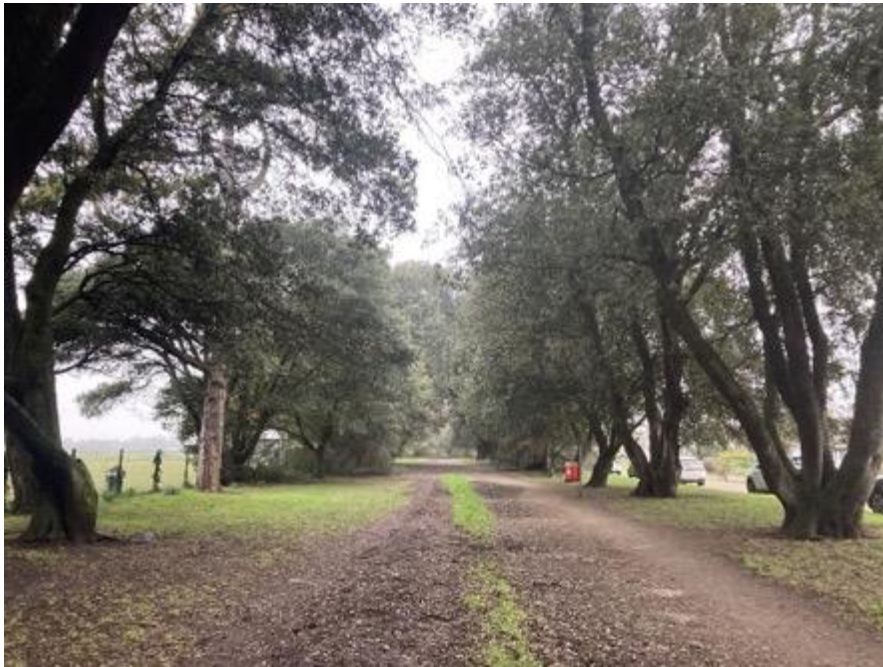
Figure 12: Ilex Avenue facing west

- 6.4 The Ilex Avenue is an important route through the conservation area, but a lack of proper management has led the track to become worn. The loss of the former grass verges and the lack of pruning of the trees has resulted in a dark enclosed space with limited views to the sea when facing south and has altered its historic character. Further maintenance issues include poor management of Ilex saplings, excessive epicormic growth, the lowering of the canopy, and presence of dead branches.

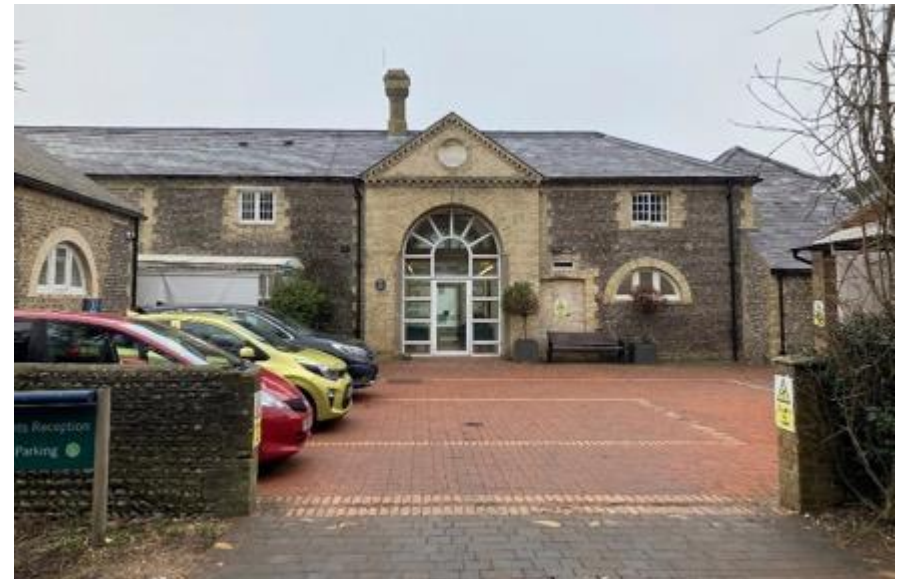
- 4.13 Within the grounds of Goring Hall there are a number of outbuildings which relate to the historic running of the house. The historic stable block (listed grade II) to the north of the hall (and now attached via a modern extension) is a brick and flint building similar to the other historic structures within the grounds. These reflect the materials found within the local area. The flint walls that enclose the grounds, service areas and walled garden are all reflective of boundary treatments within the conservation area and wider locale.

Figure 13: Former Stable building to Goring Hall (listed grade II)

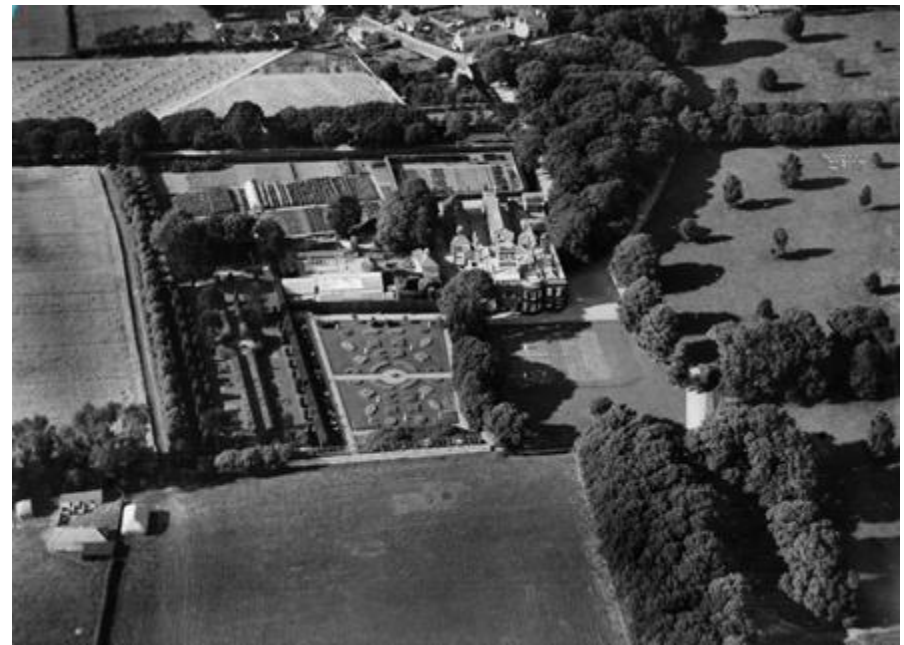
- 4.15 An aerial photograph of 1924 shows the grounds to Goring Hall in greater detail. The ornamental Italianate gardens appear very well maintained at this date, with glasshouses, kitchen gardens and stabling west and north of the house. A pergola runs the length of the terrace, and the lawns immediately south of the house have tennis courts installed by this date.

- 4.16 Parkland is shown to the east of the house, with the Ilex Avenue and The Plantation well established. The parkland today has been lost to 20th century housing development.

Figure 14: Goring Hall Estate, 1924; Source: Britain from Above

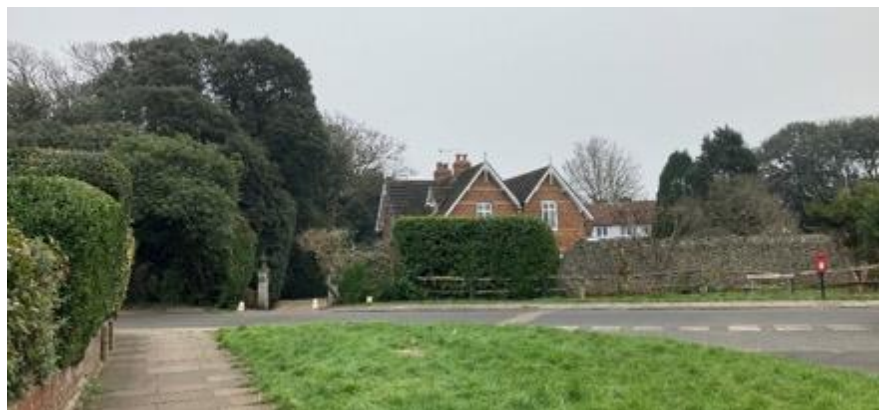
Figure 16: North Lodge and historic access to Goring Hall

- 4.25 North Lodge, the former gate lodge at the northern entrance dates to the rebuilding of Goring Hall in 1888. This building remains largely within its original footprint, although the chimneys have been shortened and the decorative bargeboards removed to the detriment of its historic character. Within its grounds, the flint wall that surrounded the estate has also been partially lost, but the remnants along Fernhurst Drive are an important example of this commonplace historic boundary feature.

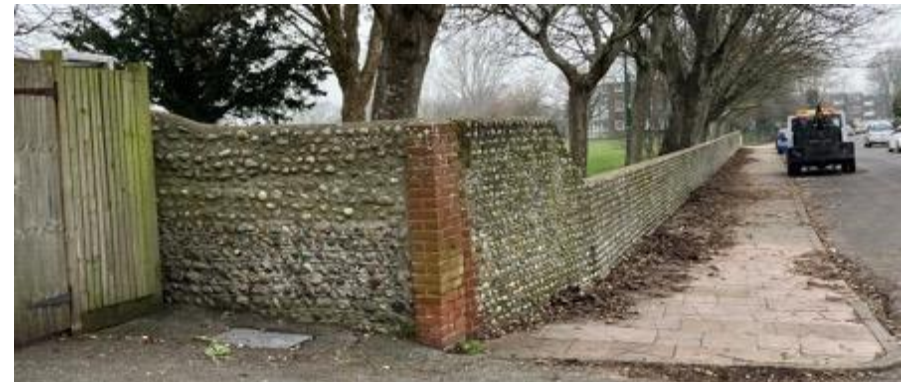
- 4.19 The Bull's Head and the flint wall to the north marks the northern extent of the conservation area. This building has entrances on Goring Street and can be accessed off Fernhurst Drive. The Bull's Head is surrounded by areas of hardstanding, in contrast to the more verdant character found elsewhere within the conservation area. To the west (rear) of the building there is a beer garden which reflects the green character of the area with mature trees and open space, but to the front of the public house the carpark provides a large area of hardstanding that detracts from its setting. A flint boundary wall runs to the north of The Bull's Head alongside the pavement of Goring Street and is another example of this type of boundary treatment that is seen throughout the local area.

Figure 17: Flint wall to the north of The Bull's Head within the conservation area.

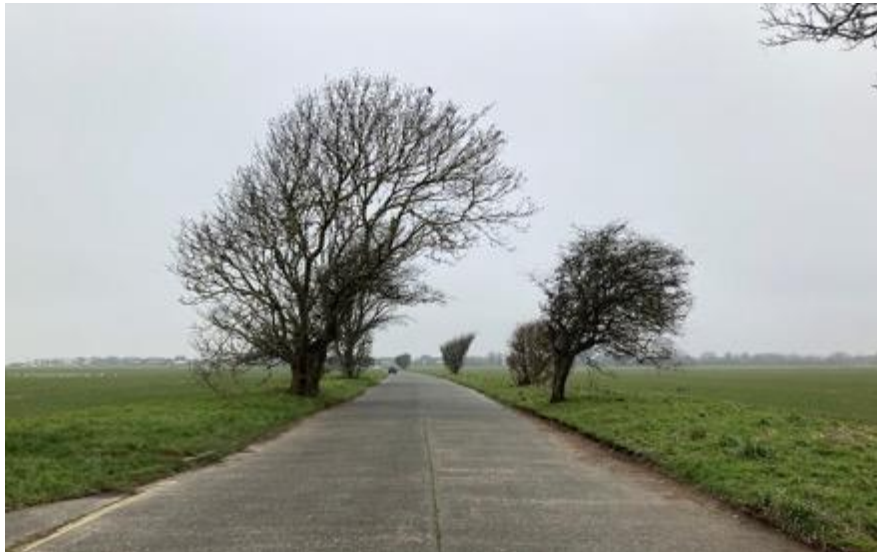
Figure 18: View facing westwards across the Goring-Ferring gap showing the roads laid out for the development of the Goring Hall estate.

- 4.22 The fields that now comprise the Goring-Ferring gap appear always to have remained in agricultural use and provide an important area of open green space that reflects the historic situation of Goring as a once small rural village and acts as a buffer to the built form of the settlement of Ferring and allows views to the South Downs to the north.

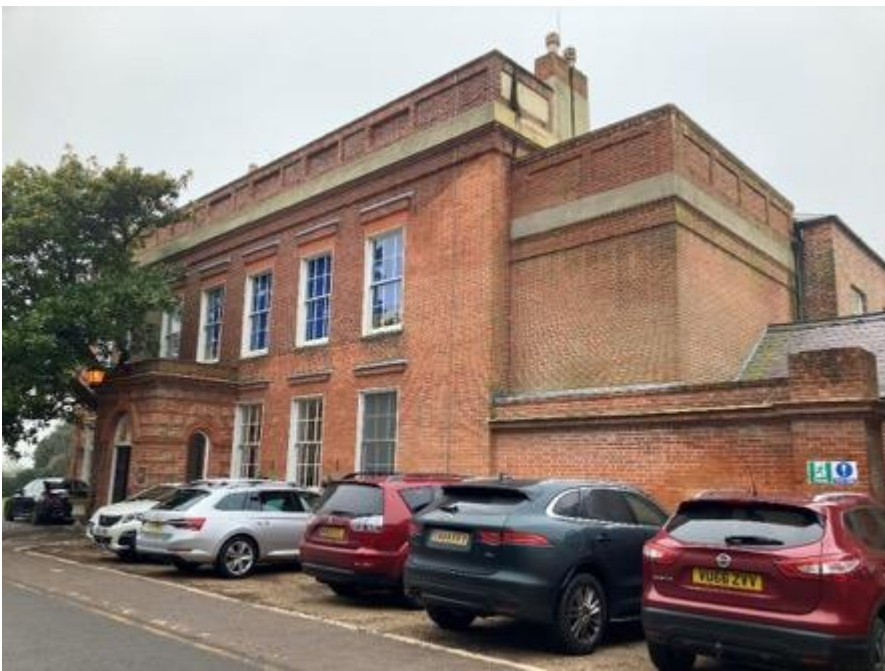
Figure 20: East facing elevation of Goring Hall with parking to front

- 4.40 The amount of hardstanding around Goring Hall, now used as parking space for the hospital and within the former walled orchard is a negative feature. This was originally green space associated with the hall and characteristic of a country estate that has been lost and now detracts from the green character of the conservation area.
- 4.41 Similarly, the car park outside of The Bull's Head southern facing elevation is a noticeable area of hardstanding within the conservation area, especially surrounding this historic building that detracts from its character and is an area where improvement could be made through the use of planting and soft landscaping.

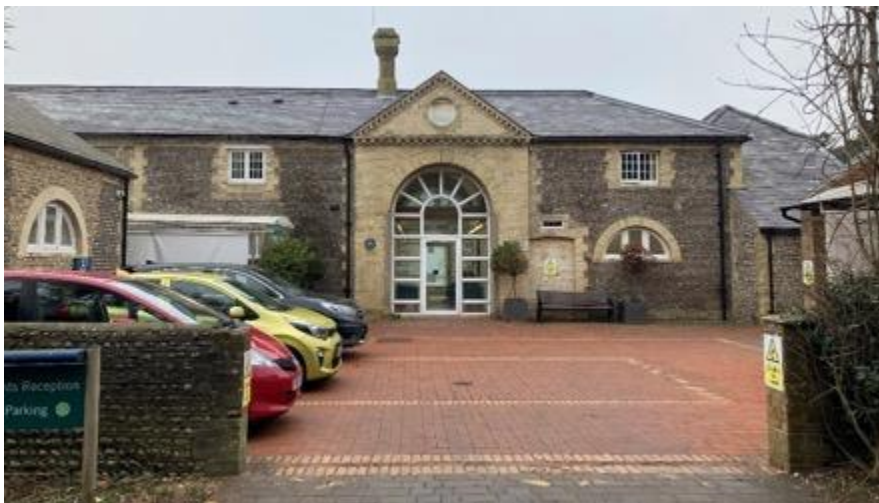
Figure 21: Former stable building at Goring Hall

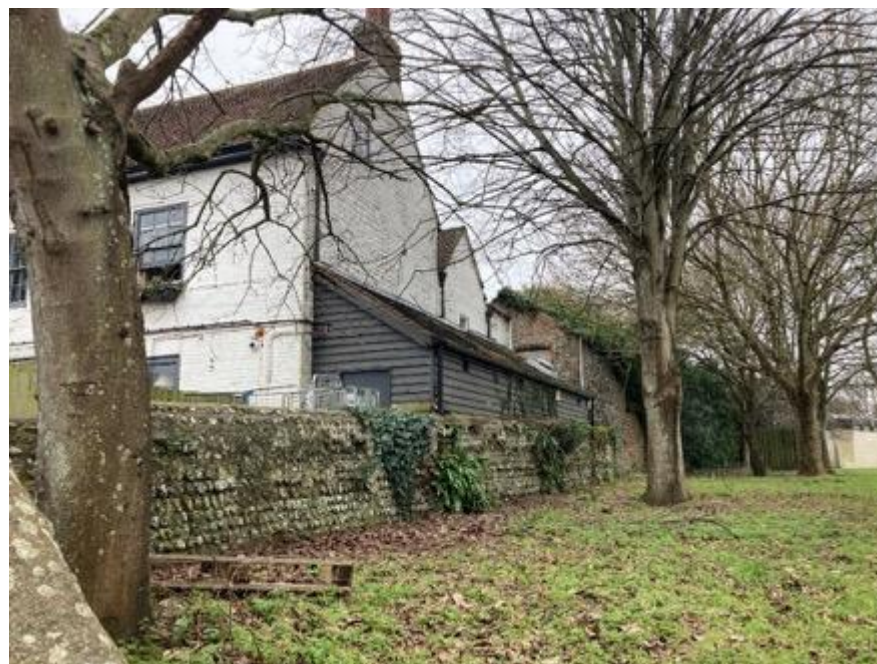
4.32 Elsewhere, The Bull's Head comprises a number of building materials, reflecting its continuous development. The materials include painted brickwork, coursed flint walls, render with red brick window dressings and weatherboarding. There is one modern building adjacent to North Lodge

Figure 23: Examples of brick, flint and weatherboarding on and next to The Bull's Head.

4.31 The most characteristic of the local building materials is flint, found in the chalk beds of the downs, and the beaches. These are used extensively in both buildings and boundary walls, as intact or broken cobbles, although there are examples of knapped and coursed flints and cobbles laid in struck lime.

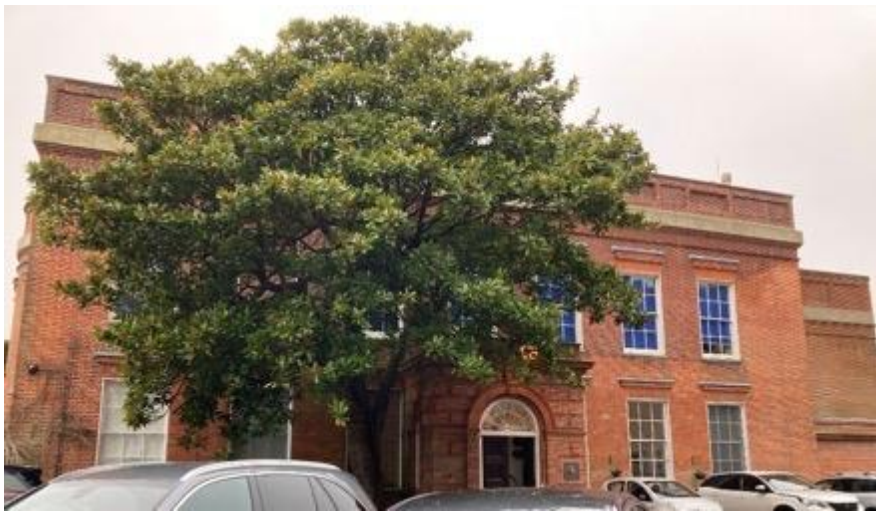
Figure 25: Brick used at Goring Hall

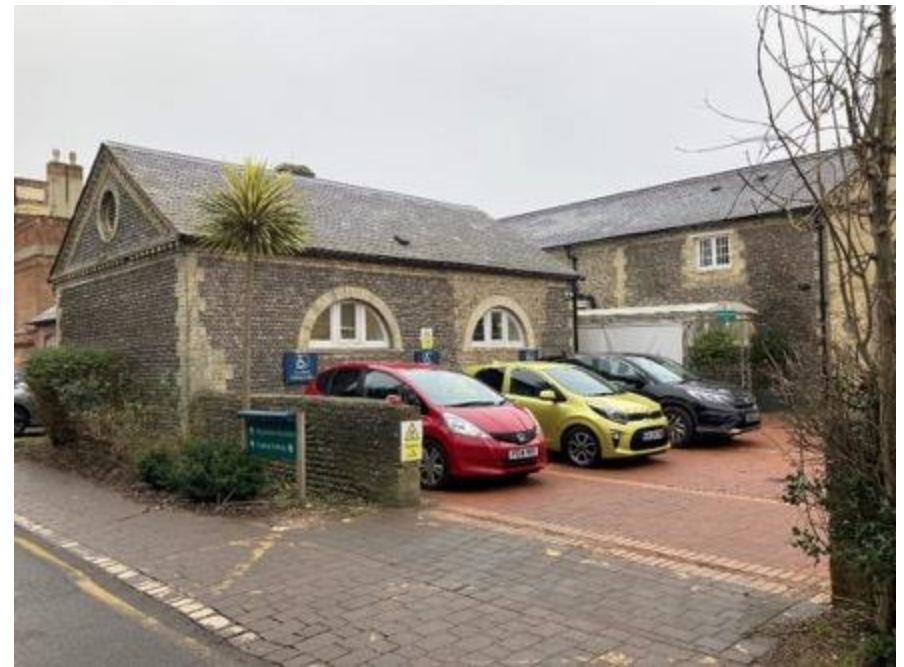
- 4.33 The unifying feature of the conservation area are the extensive flint boundary walls, which surround the historic Goring Hall estate and the land to the north of The Bull's Head. The flint walls are not homogenous, but vary in terms of their height, intactness, quality and age. Some are built of coursed cobbled flints, while others are made of broken flints laid in a more random arrangement.
- 4.34 Roads and pavements throughout the conservation area are predominantly in modern tarmac or concrete paving slabs. The Ilex Avenue is a dirt track, closed to vehicles. The historic approach to the Goring Hall Estate from North Lodge is covered in gravel, disguising any earlier road treatment. Within Goring Hall grounds, the predominant road material is tarmac, but there are examples of brick and block paving within the historic service yard area.

Figure 26: Examples of paving treatments in Goring Hall grounds.

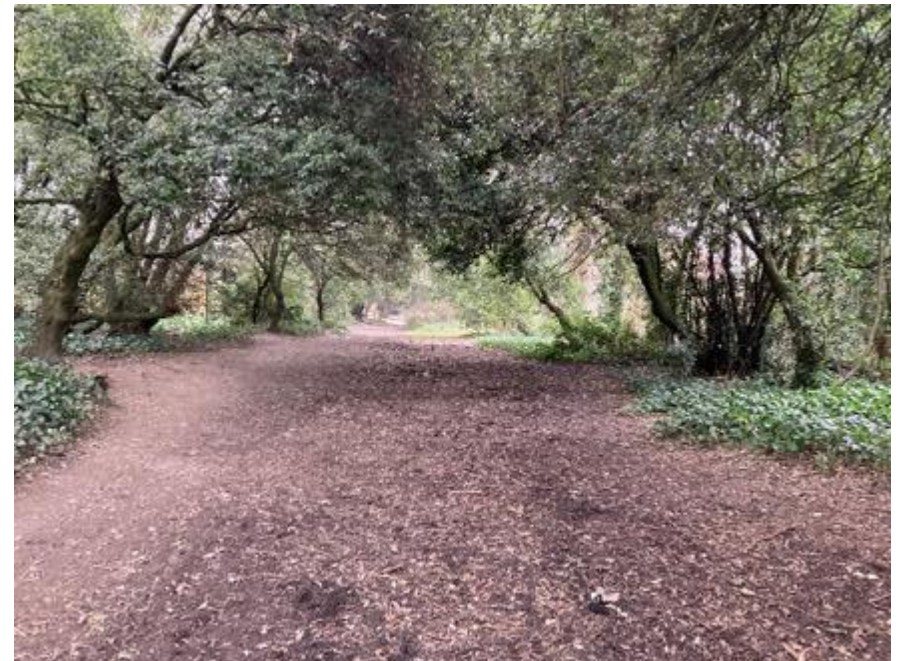
Figure 27: Dirt track along Ilex Avenue

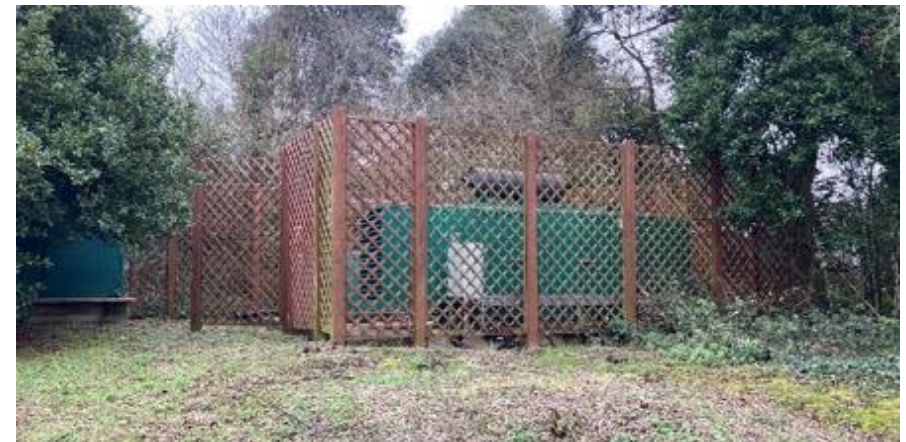
Figure 28: Plant within the grounds of Goring Hall

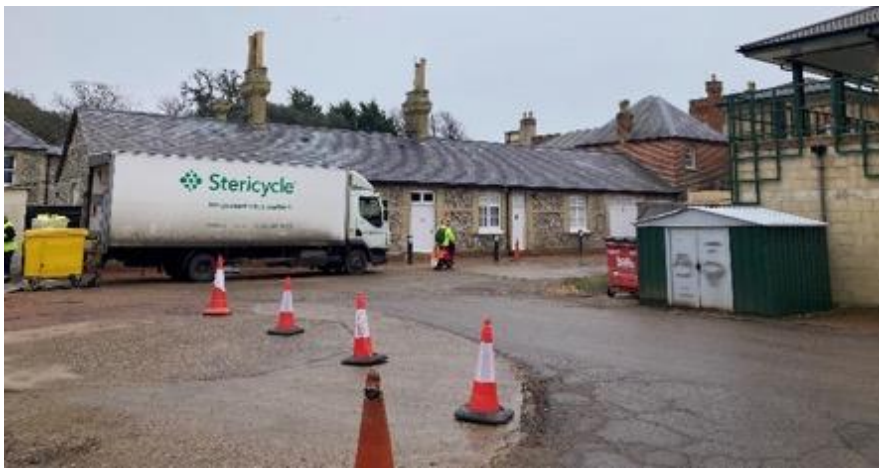
Figure 29: Extensive areas of hardstanding within the grounds of Goring Hall

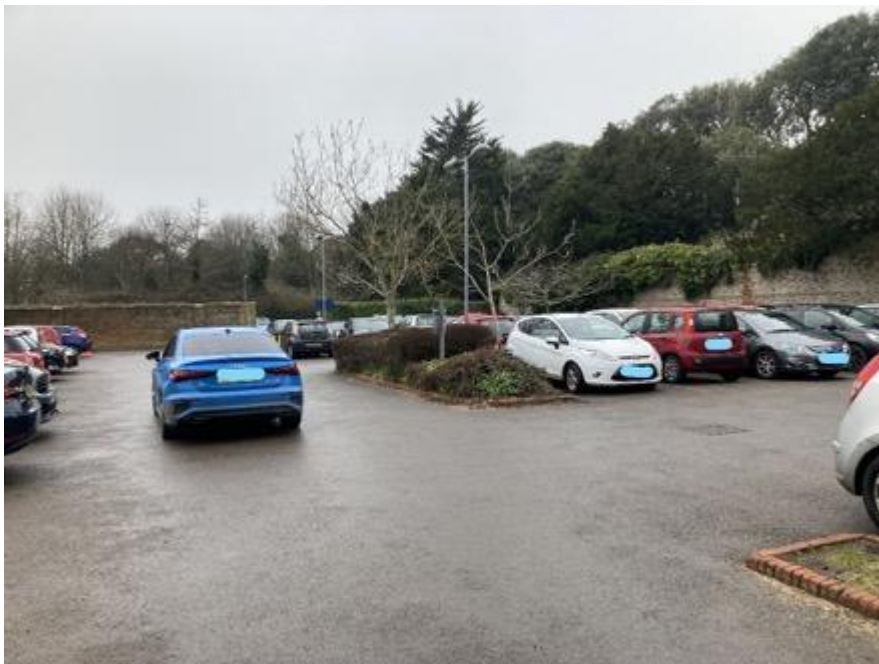
Figure 30: Carpark within the former orchard of Goring Hall

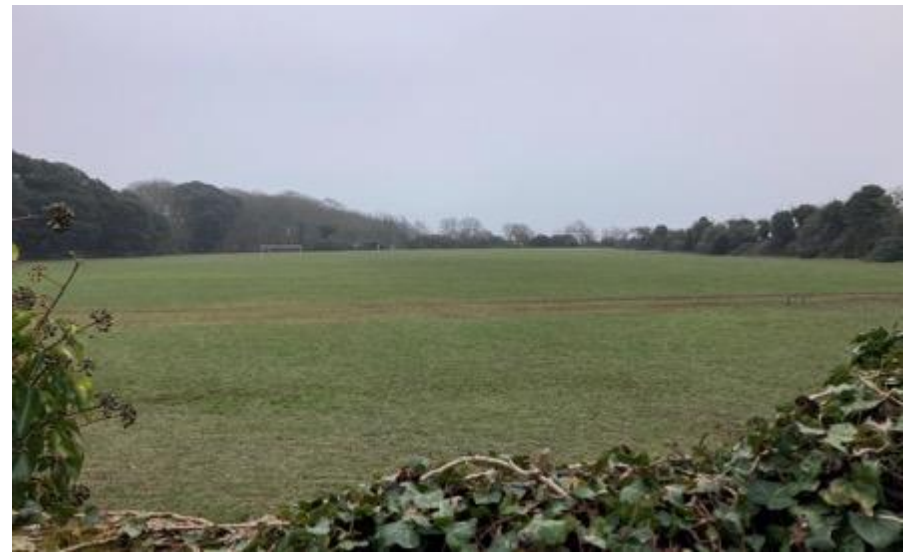
Figure 32: View from the raised promenade at Goring Hall to the south

- 5.3 Views from Goring Hall southwards are also of importance. These allow views to the open space beyond, which would have formerly allowed unrestricted views to the sea and are reflective of an important aspect of the buildings location. Views to the south are from the formal gardens with a raised walkway at the southern boundary of the halls grounds. The mature vegetation has restricted views to the sea, but there are likely to be views to the sea from the upper floors of the building.

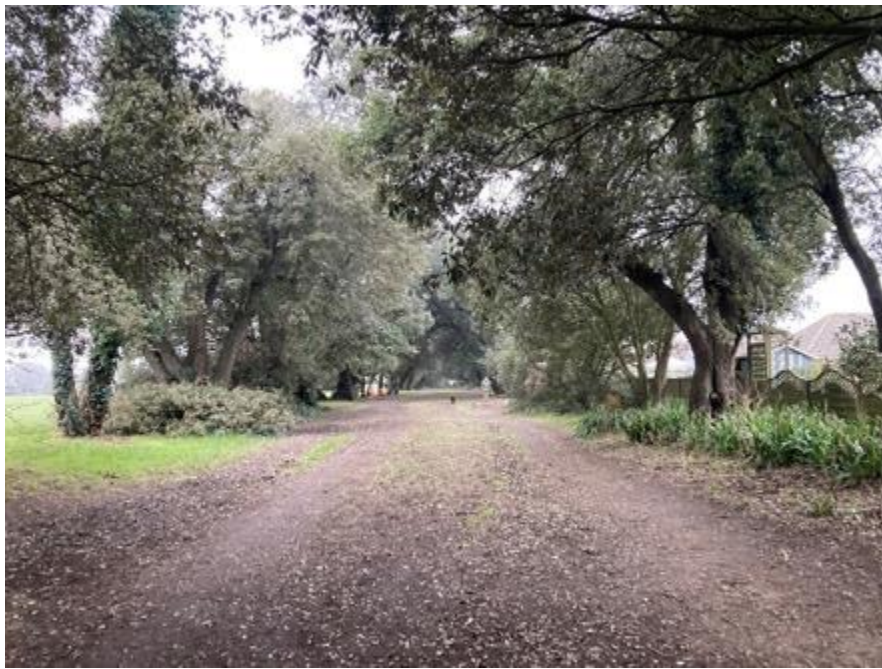
Figure 33: View westwards along Ilex Avenue

- 5.4 Due to the enclosed nature of the Ilex Avenue and its historical approach to Goring Hall views are channelled along this approach from the east and west. These are kinetic (changing) views that are best appreciated while progressing along the avenue. They contribute to a sense of the original access to the estate of Goring Hall and today obscure the more modern housing to the north and south of the conservation area. However, the overgrown nature of some of the trees provides a dark enclosed space with little opportunity to view the sea to the south.

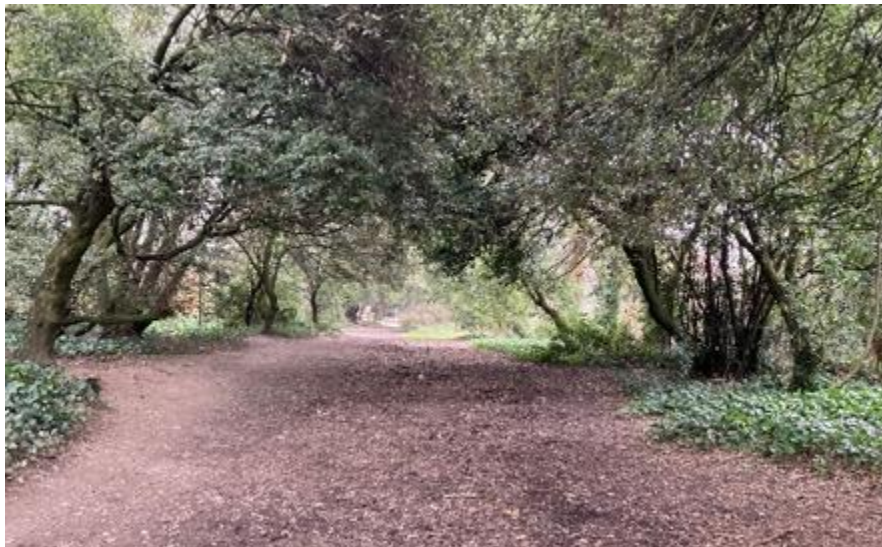
Figure 34: Views Eastwards along Ilex Avenue towards Sea Lane, Goring

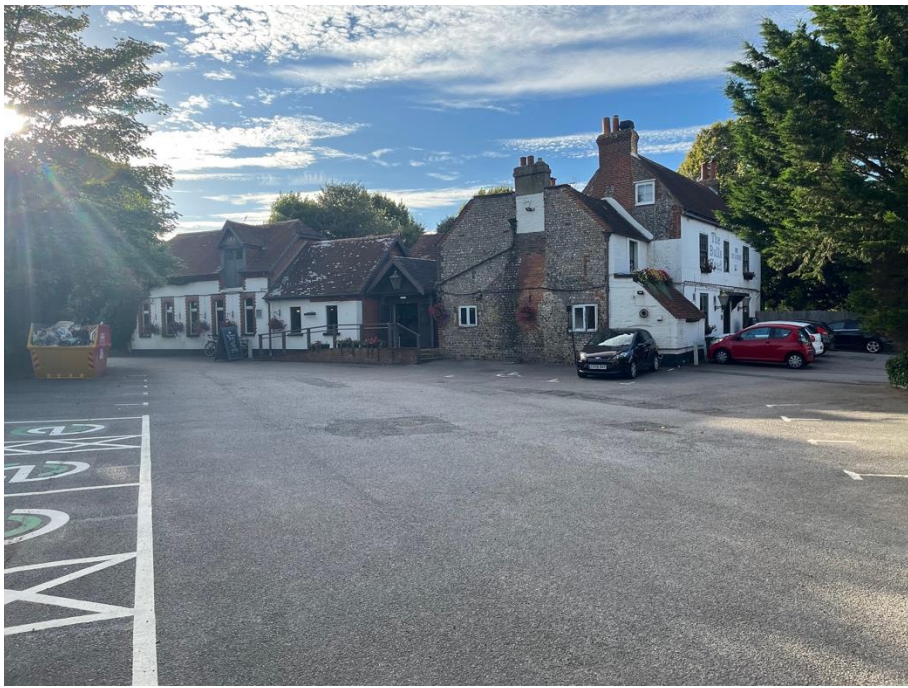
Figure 36: Hardstanding at the Bull's Head
